POOL REFURBISHMENT WORK Earth Digging, Bed Soling, Bed/Floor Concrete & brick wall construction for Overflow Balance tank

PREEMIYAR POOLS PVT LTD best pool for better swimming ...

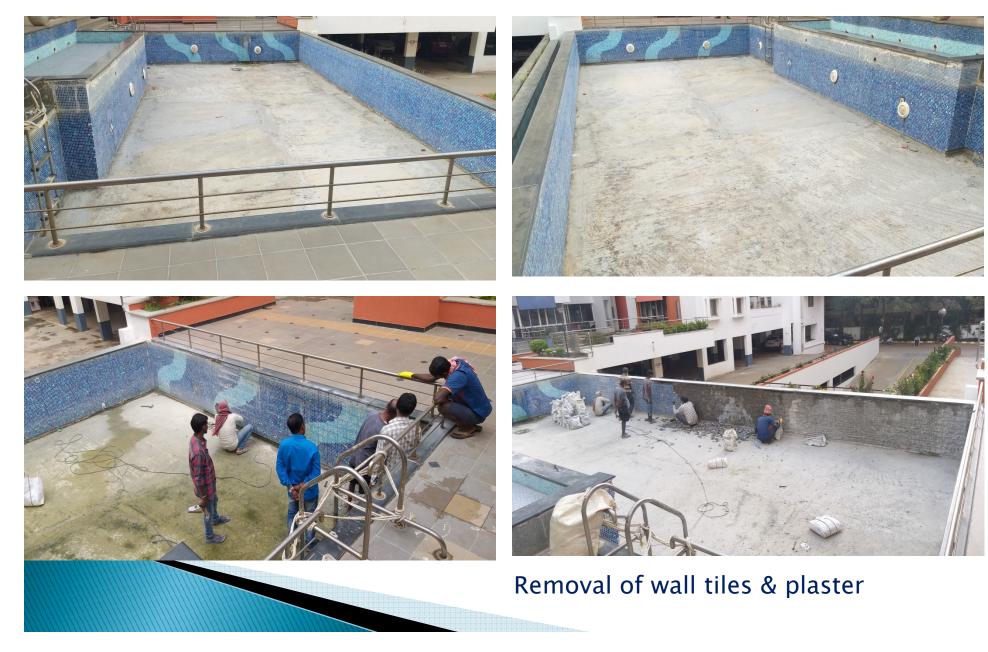
Cleaning of entire pool area and filled all the debris in proper packaging bags.

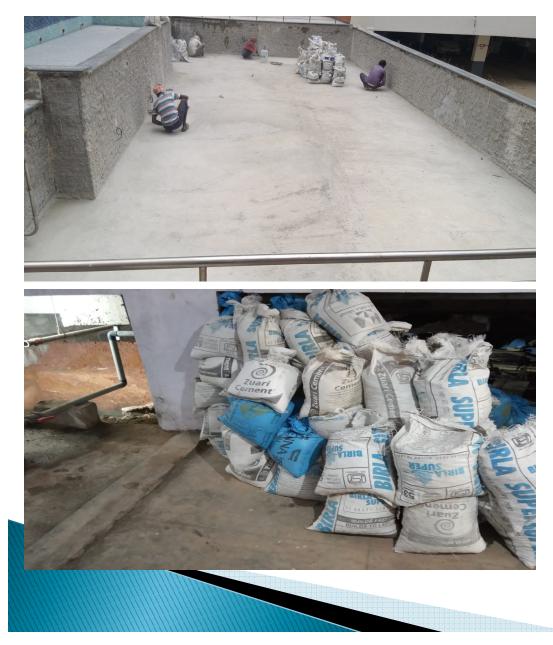
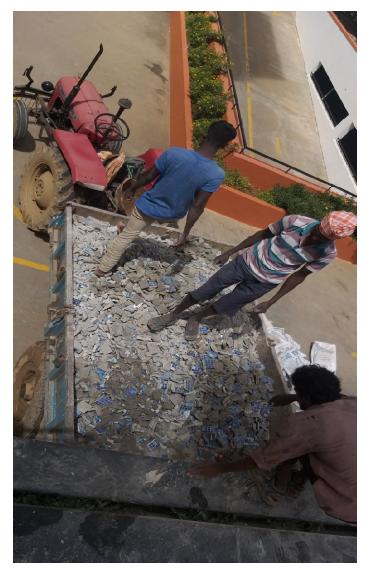
Debris disposal thru Tractor

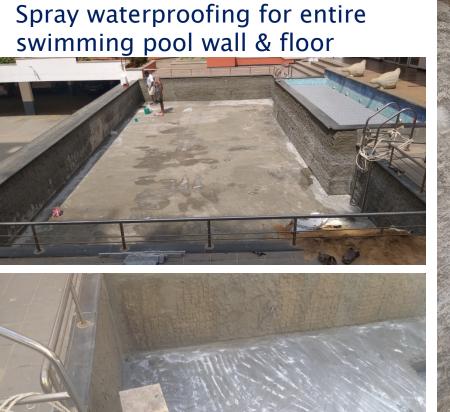
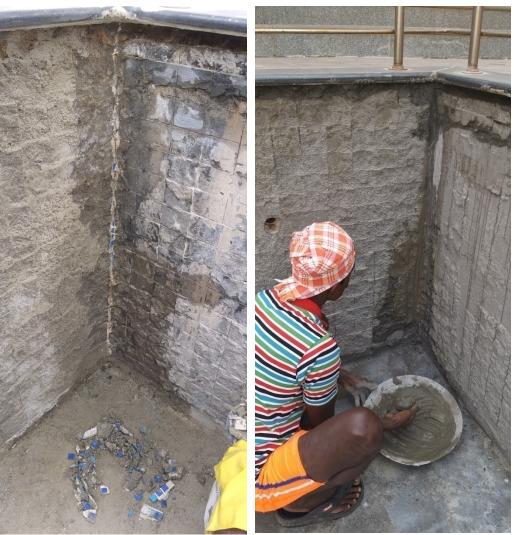
Identified & Rectified leakage issues with proper waterproof material

Brush waterproofing for pool floor & wall

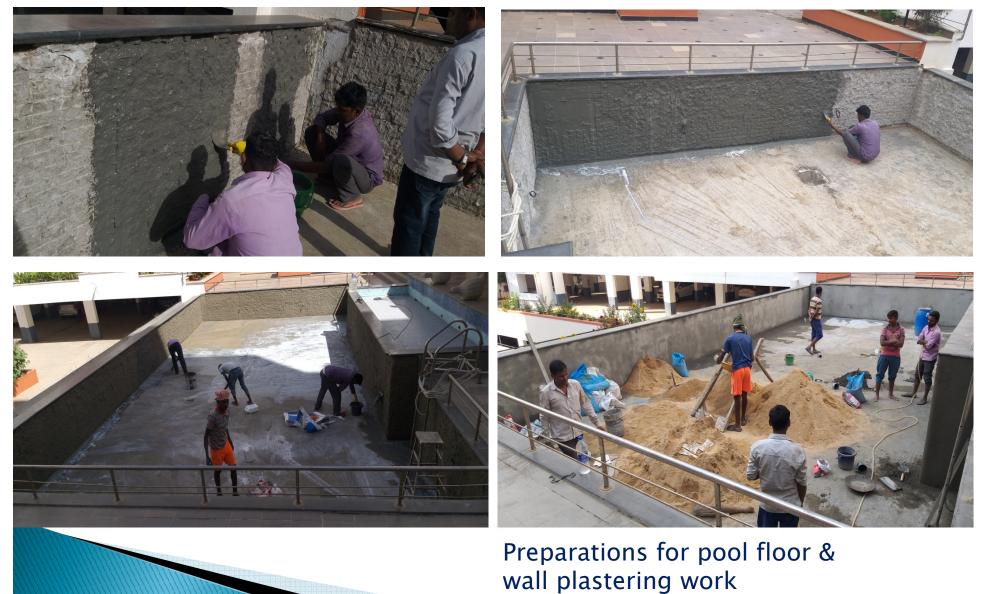
Swimming Pool wall & floor plastering

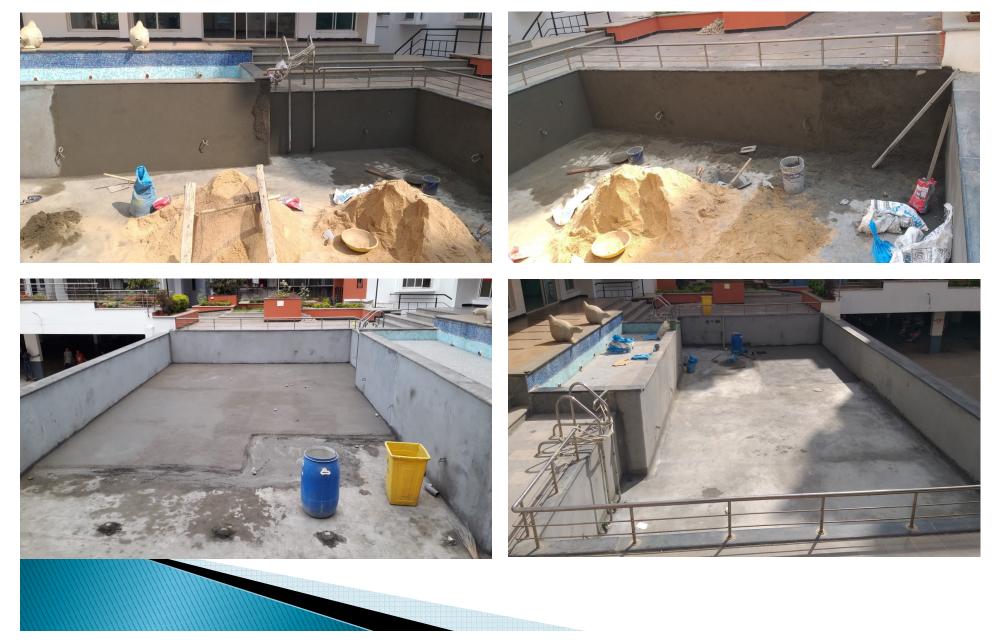
Water filled for Curing Purpose $\rightarrow \rightarrow \rightarrow$

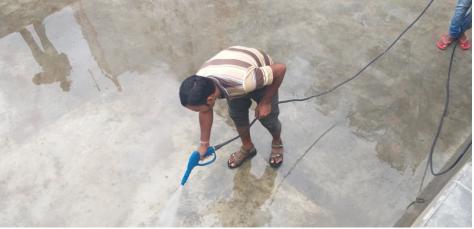
High pressure jet cleaning of pool after curing to start tiling work

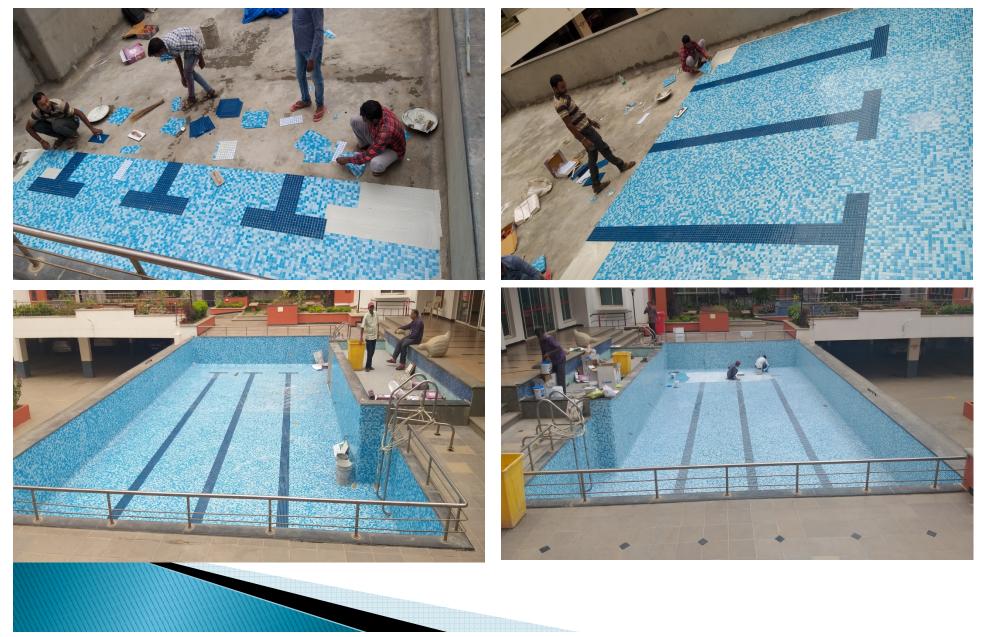
'V' Notch gap filling between coping stone granites, correction of overflow drain, application of grout & epoxy paint on floor & wall of overflow drain.

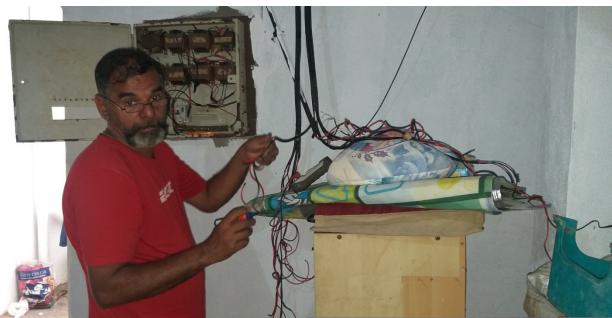
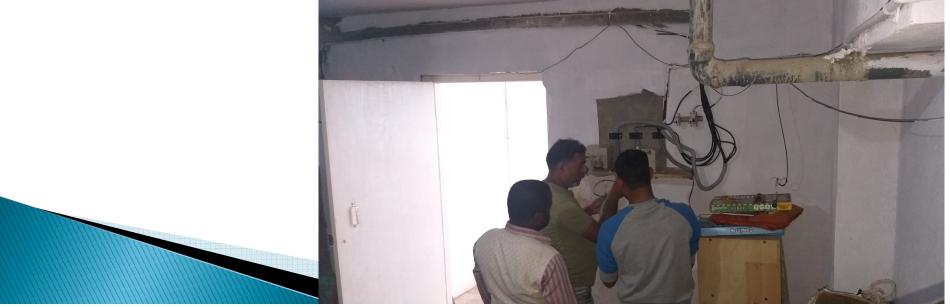
LED Light Fixing & Switching 'ON' of lights

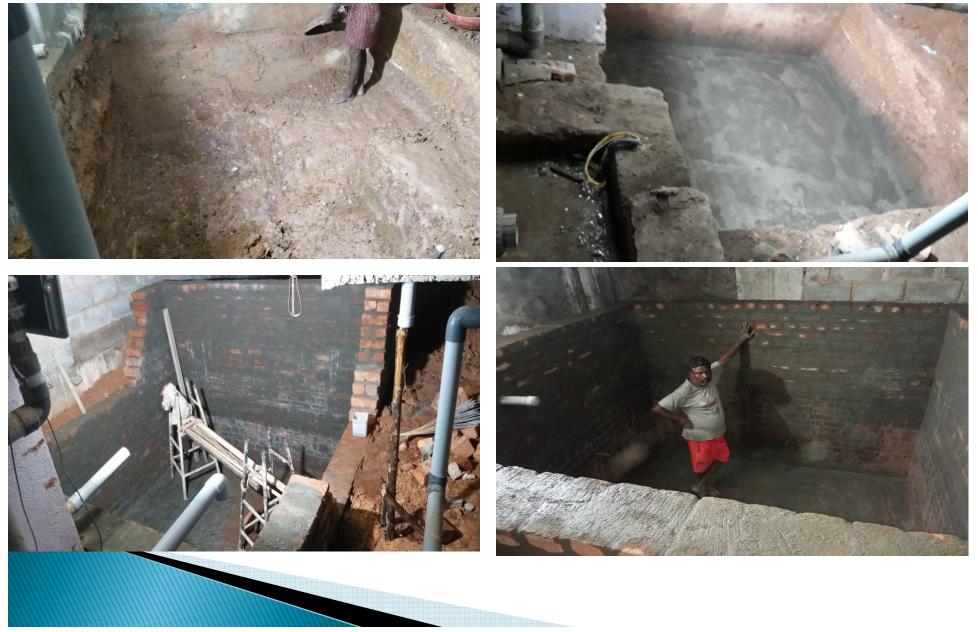
POOL REFURBISHMENT WORK Spray & Brush waterproofing, Plastering of Balance tank & roof leakage issue rectification
